KOP 29
Gonder Substation

Figure 3.9-30

Falcon to Gonder Project EIS

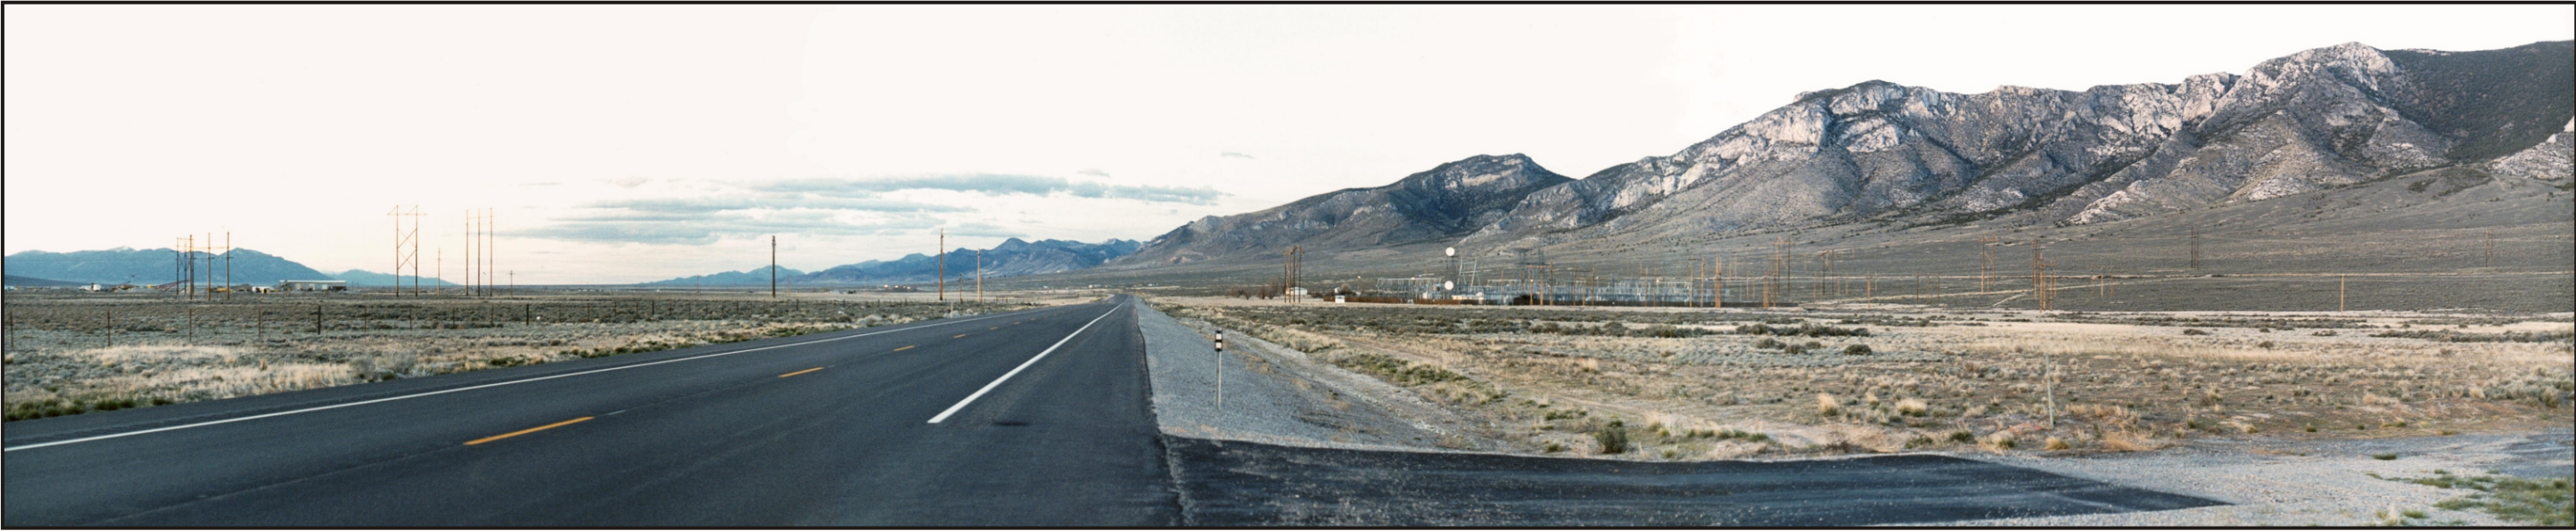
Context Photograph

Summary of Visual Changes

Type/Sensitivity of Users: Local and long distance travelers with a moderate concern for visual quality
Volume of Users: High
T/L Distance from Viewer: Background to foreground crossing views
T/L Prominence in Landscape: Low - seen in a valley situation with topographic backdrops except at close distances
Existing Modifications: The Gonder substation is located adjacent to the highway with numerous transmission lines converging from various locations

Contrast Rating: Low
VRM Class: IV (Interim)
Visual Impact Rating: Low
